LINKING WATER SUPPLY TO WATERSHED RESTORATION

American Water Resources Association

William Meyer, WDFW YBIP

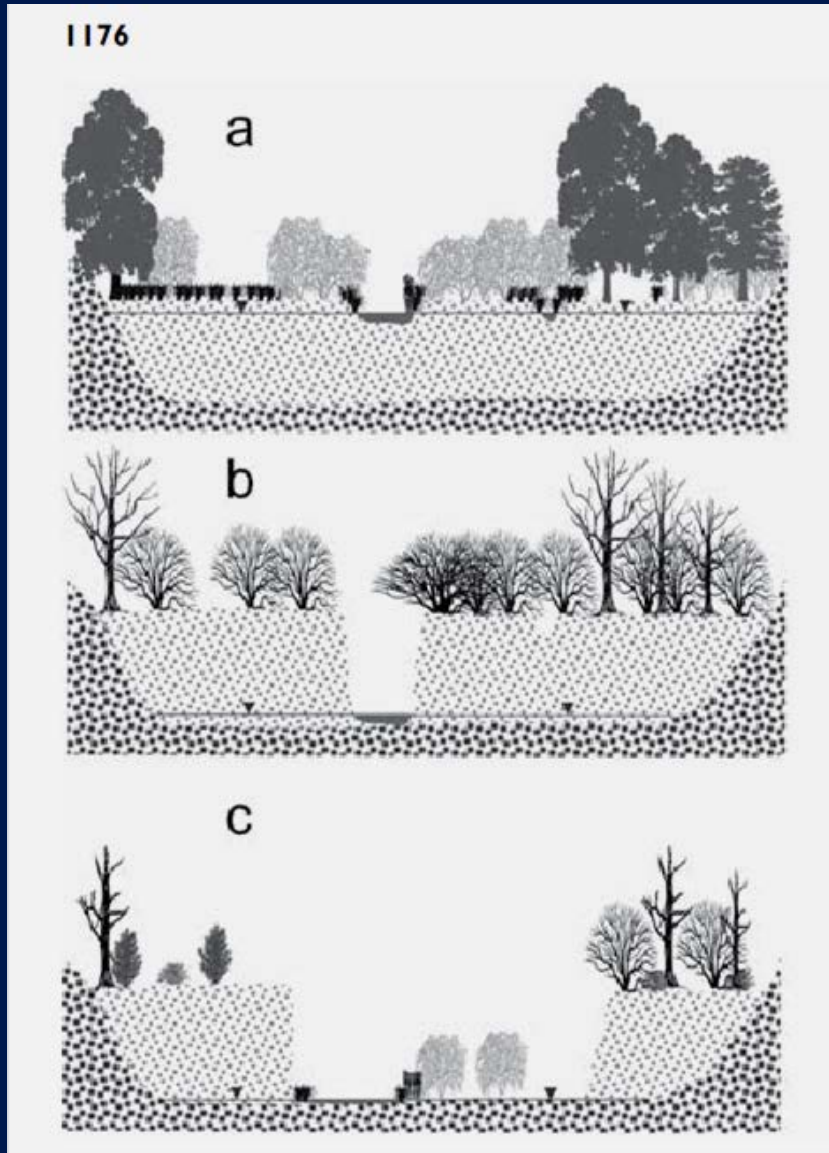
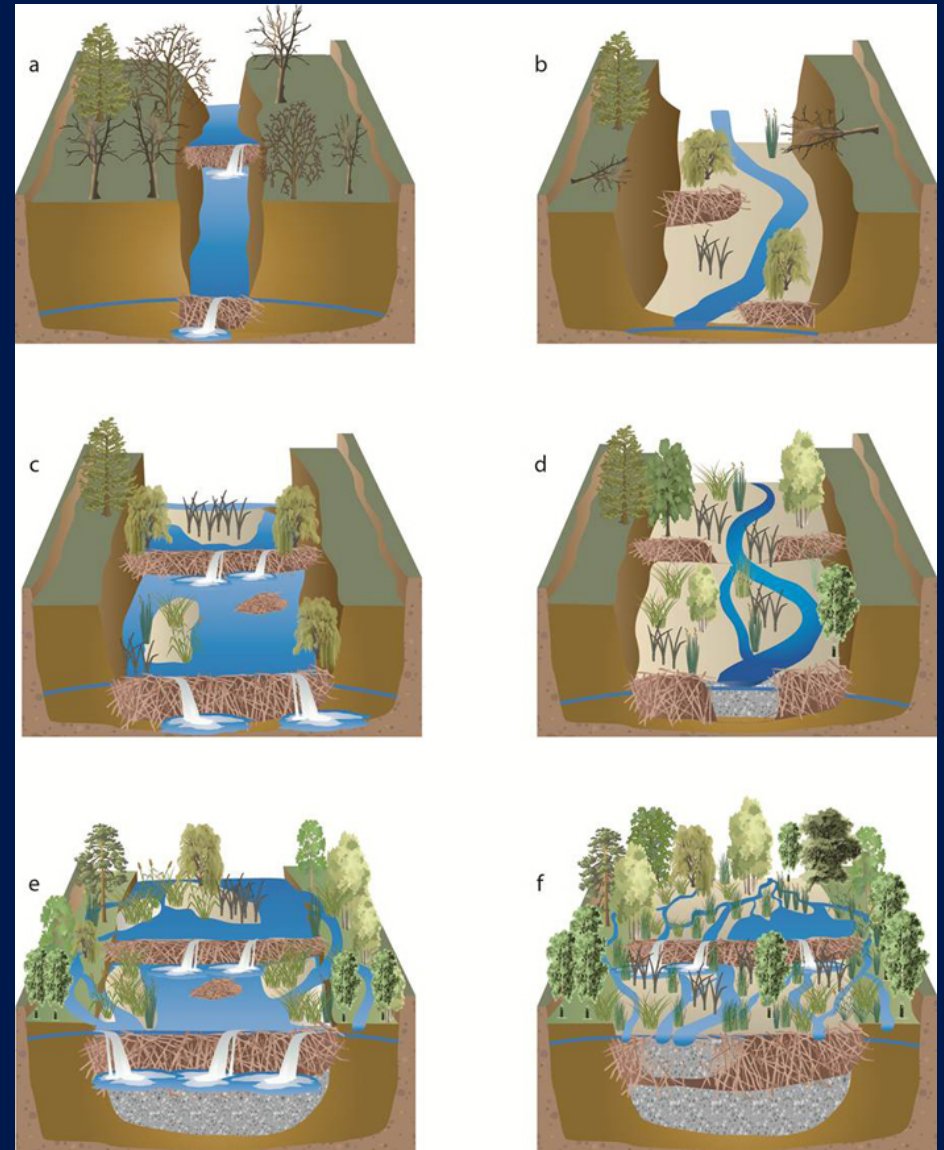
Geomorphic changes upstream of beaver dams in Bridge Creek, an incised stream channel in the interior Columbia River Basin, eastern Oregon Pollock et. al. 2007

Simplified Incised Stream

- Disconnected floodplain
- Lowered water table

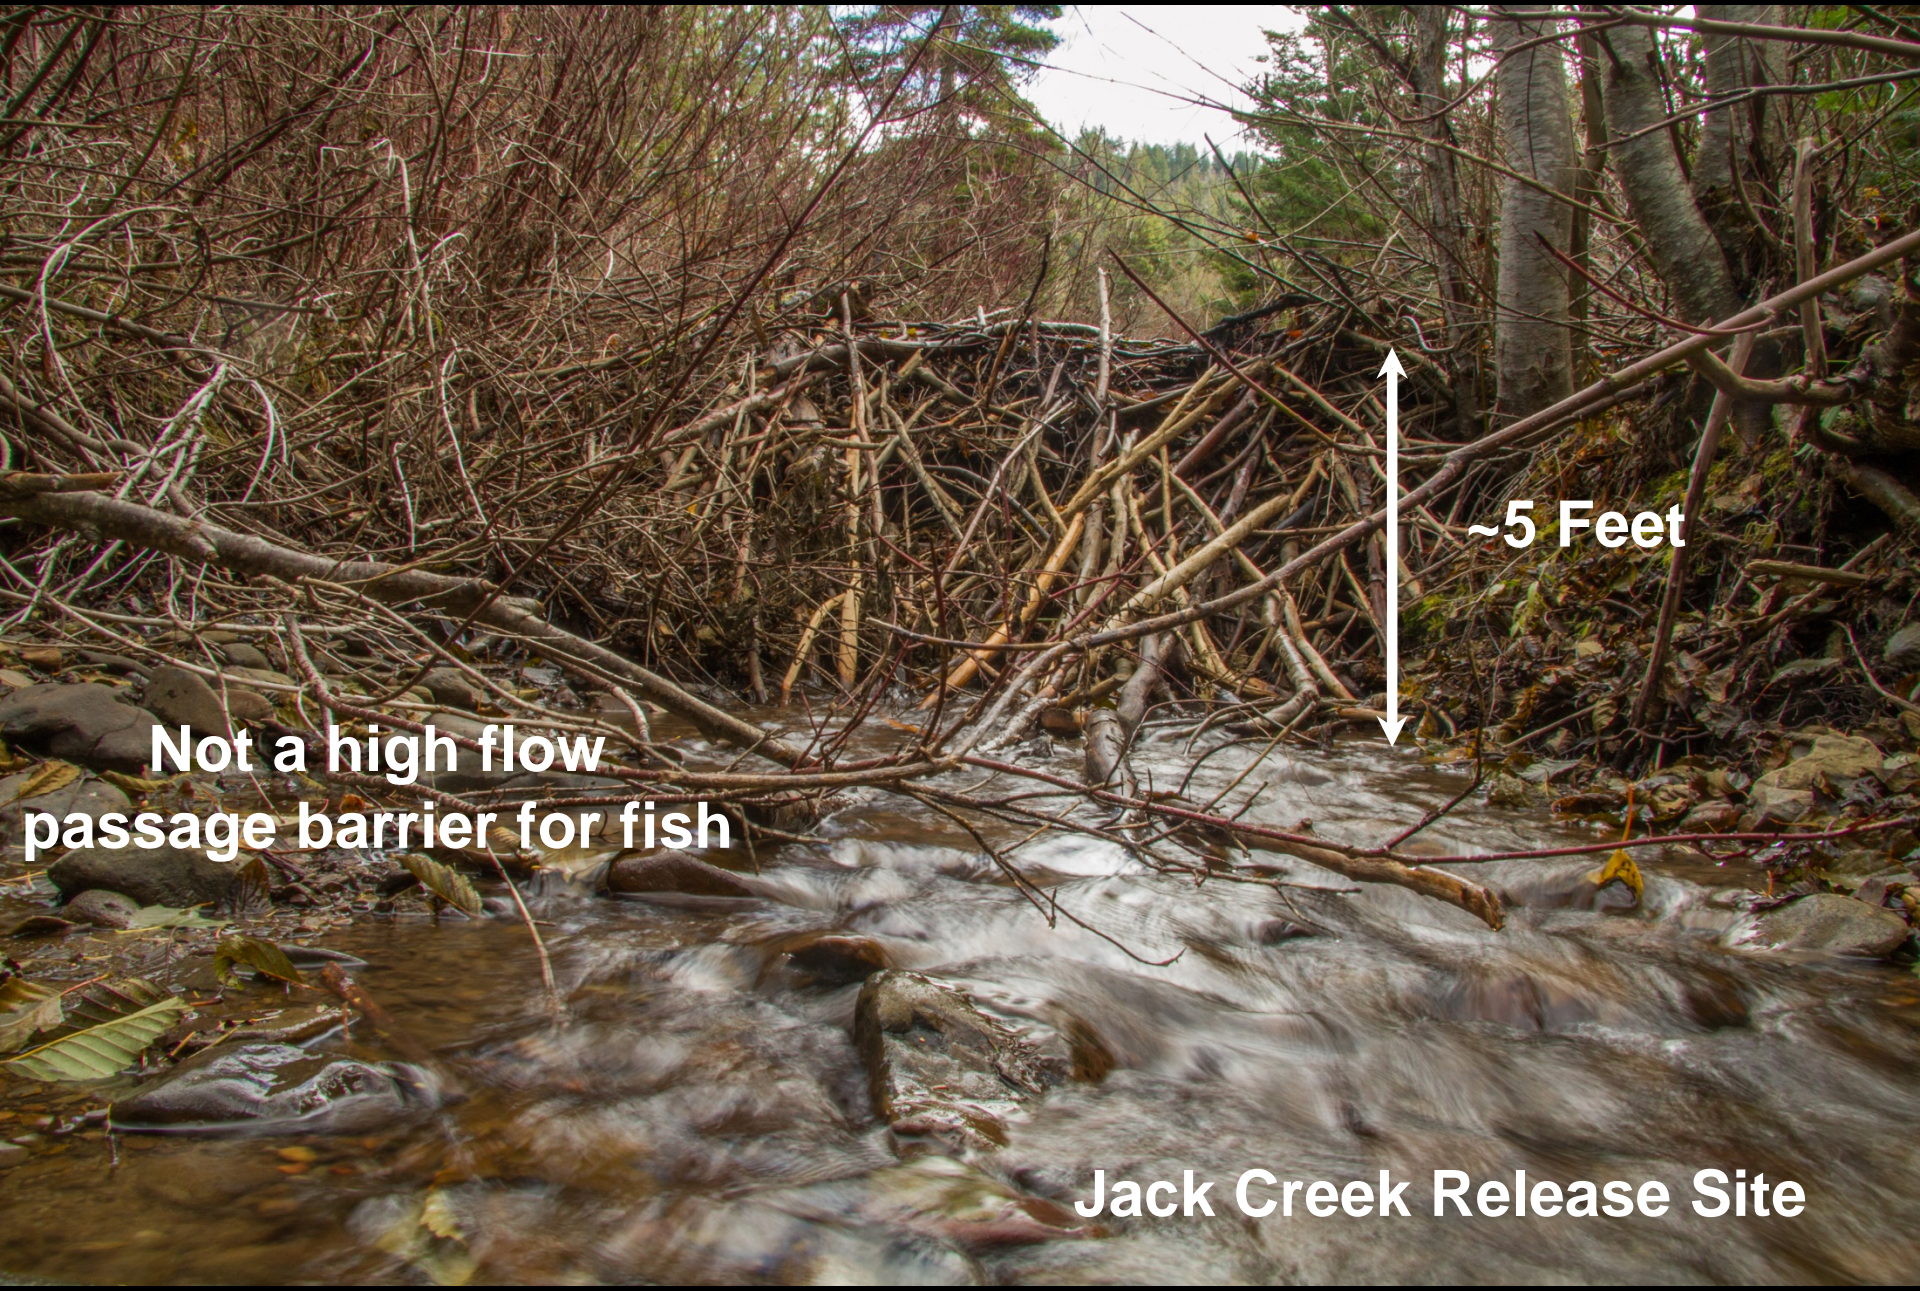
~5 Feet

Not a high flow
passage barrier for fish

Jack Creek Release Site

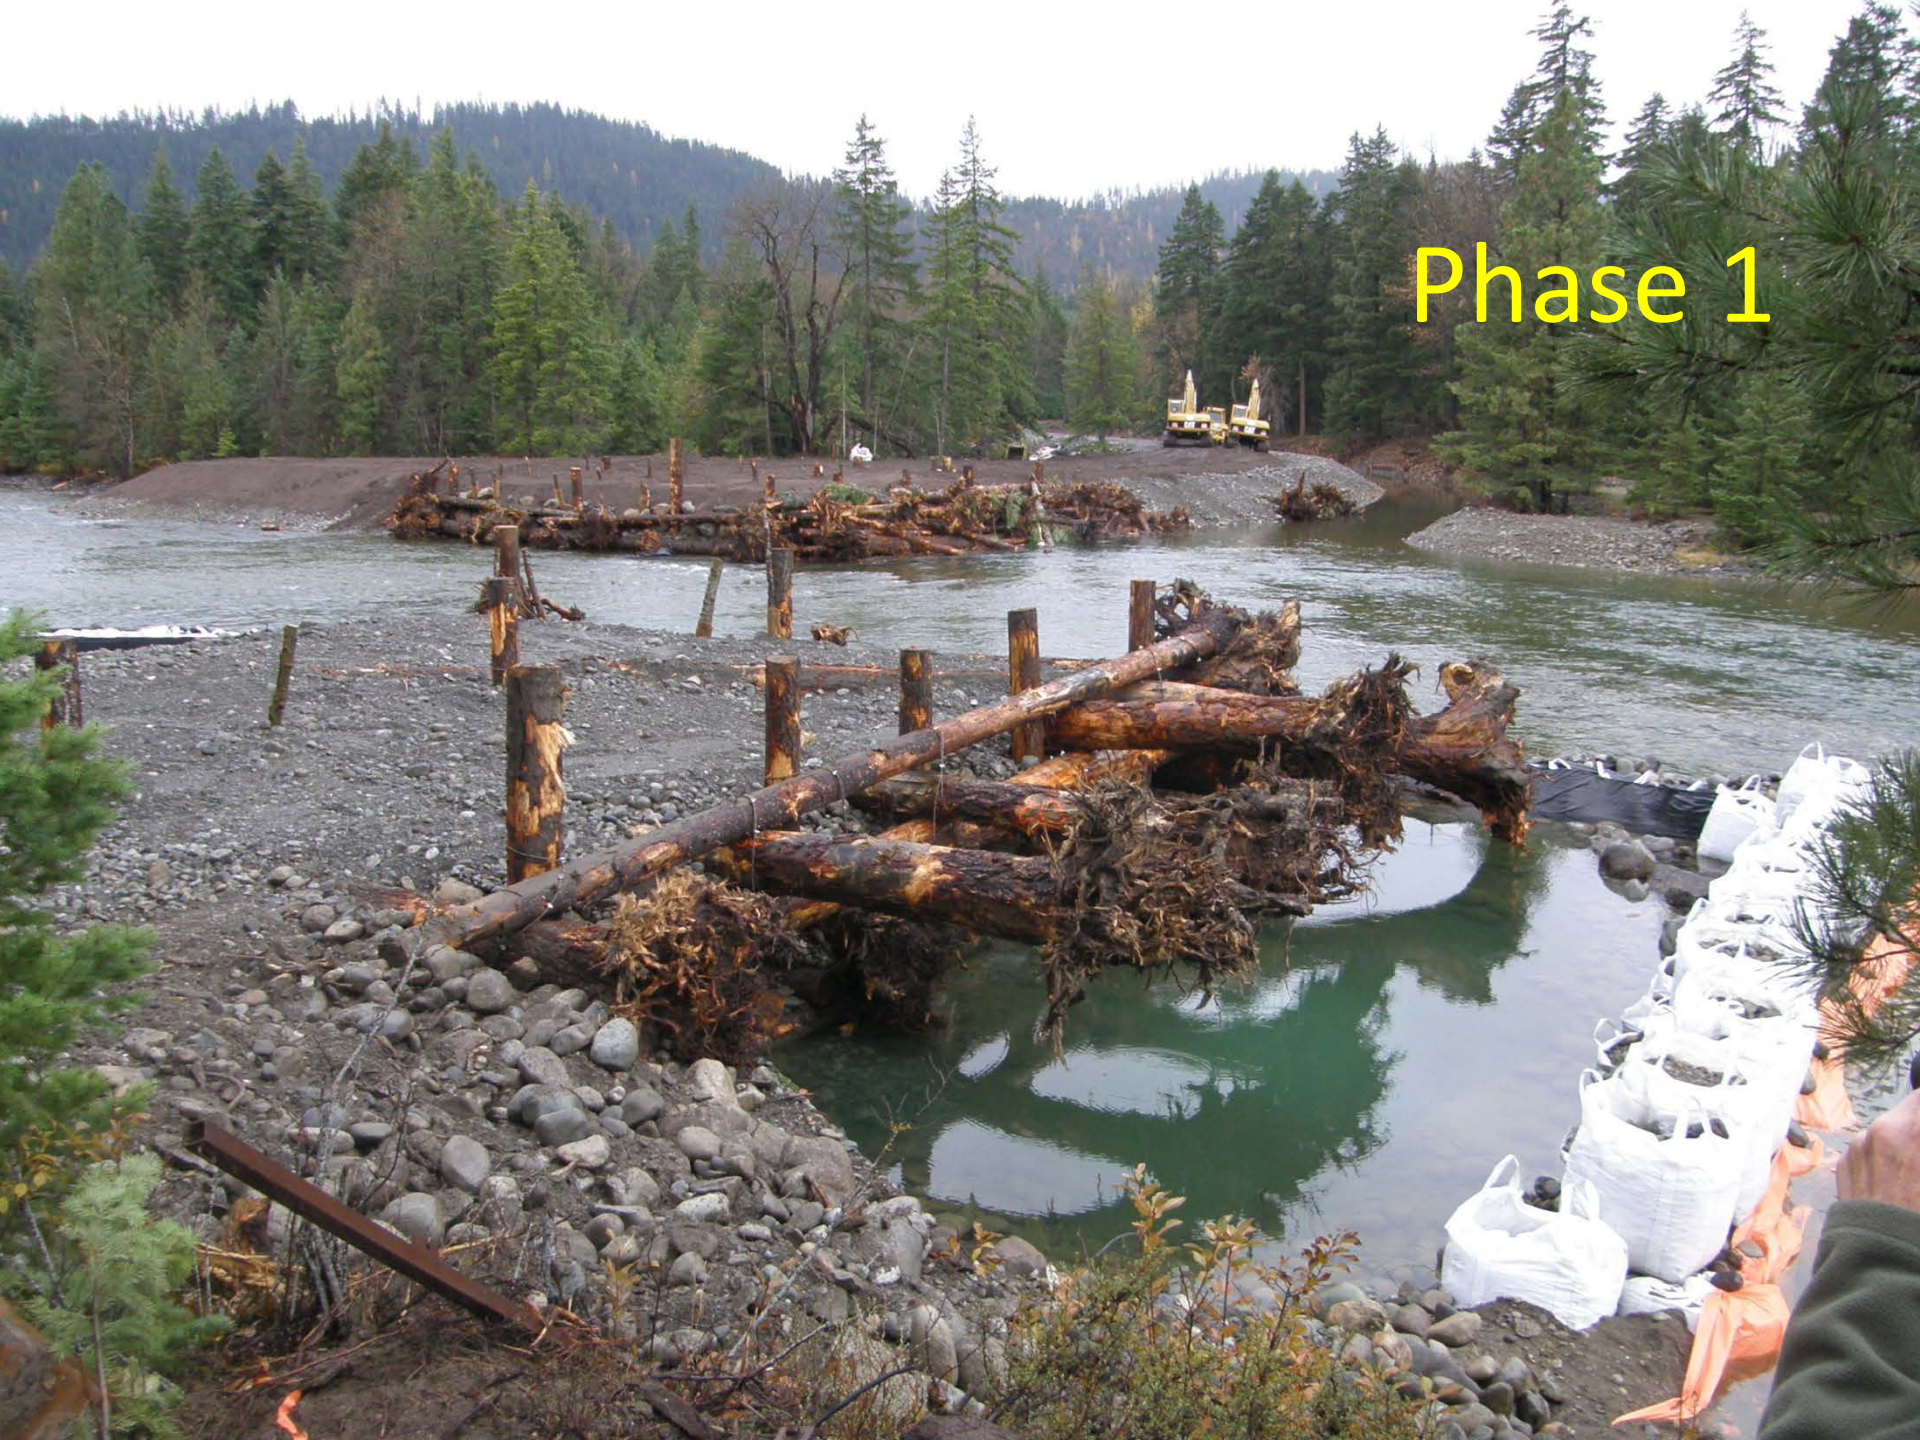
Cle Elum River 2009

Pre-Project Wetted Channel @ 220 cfs

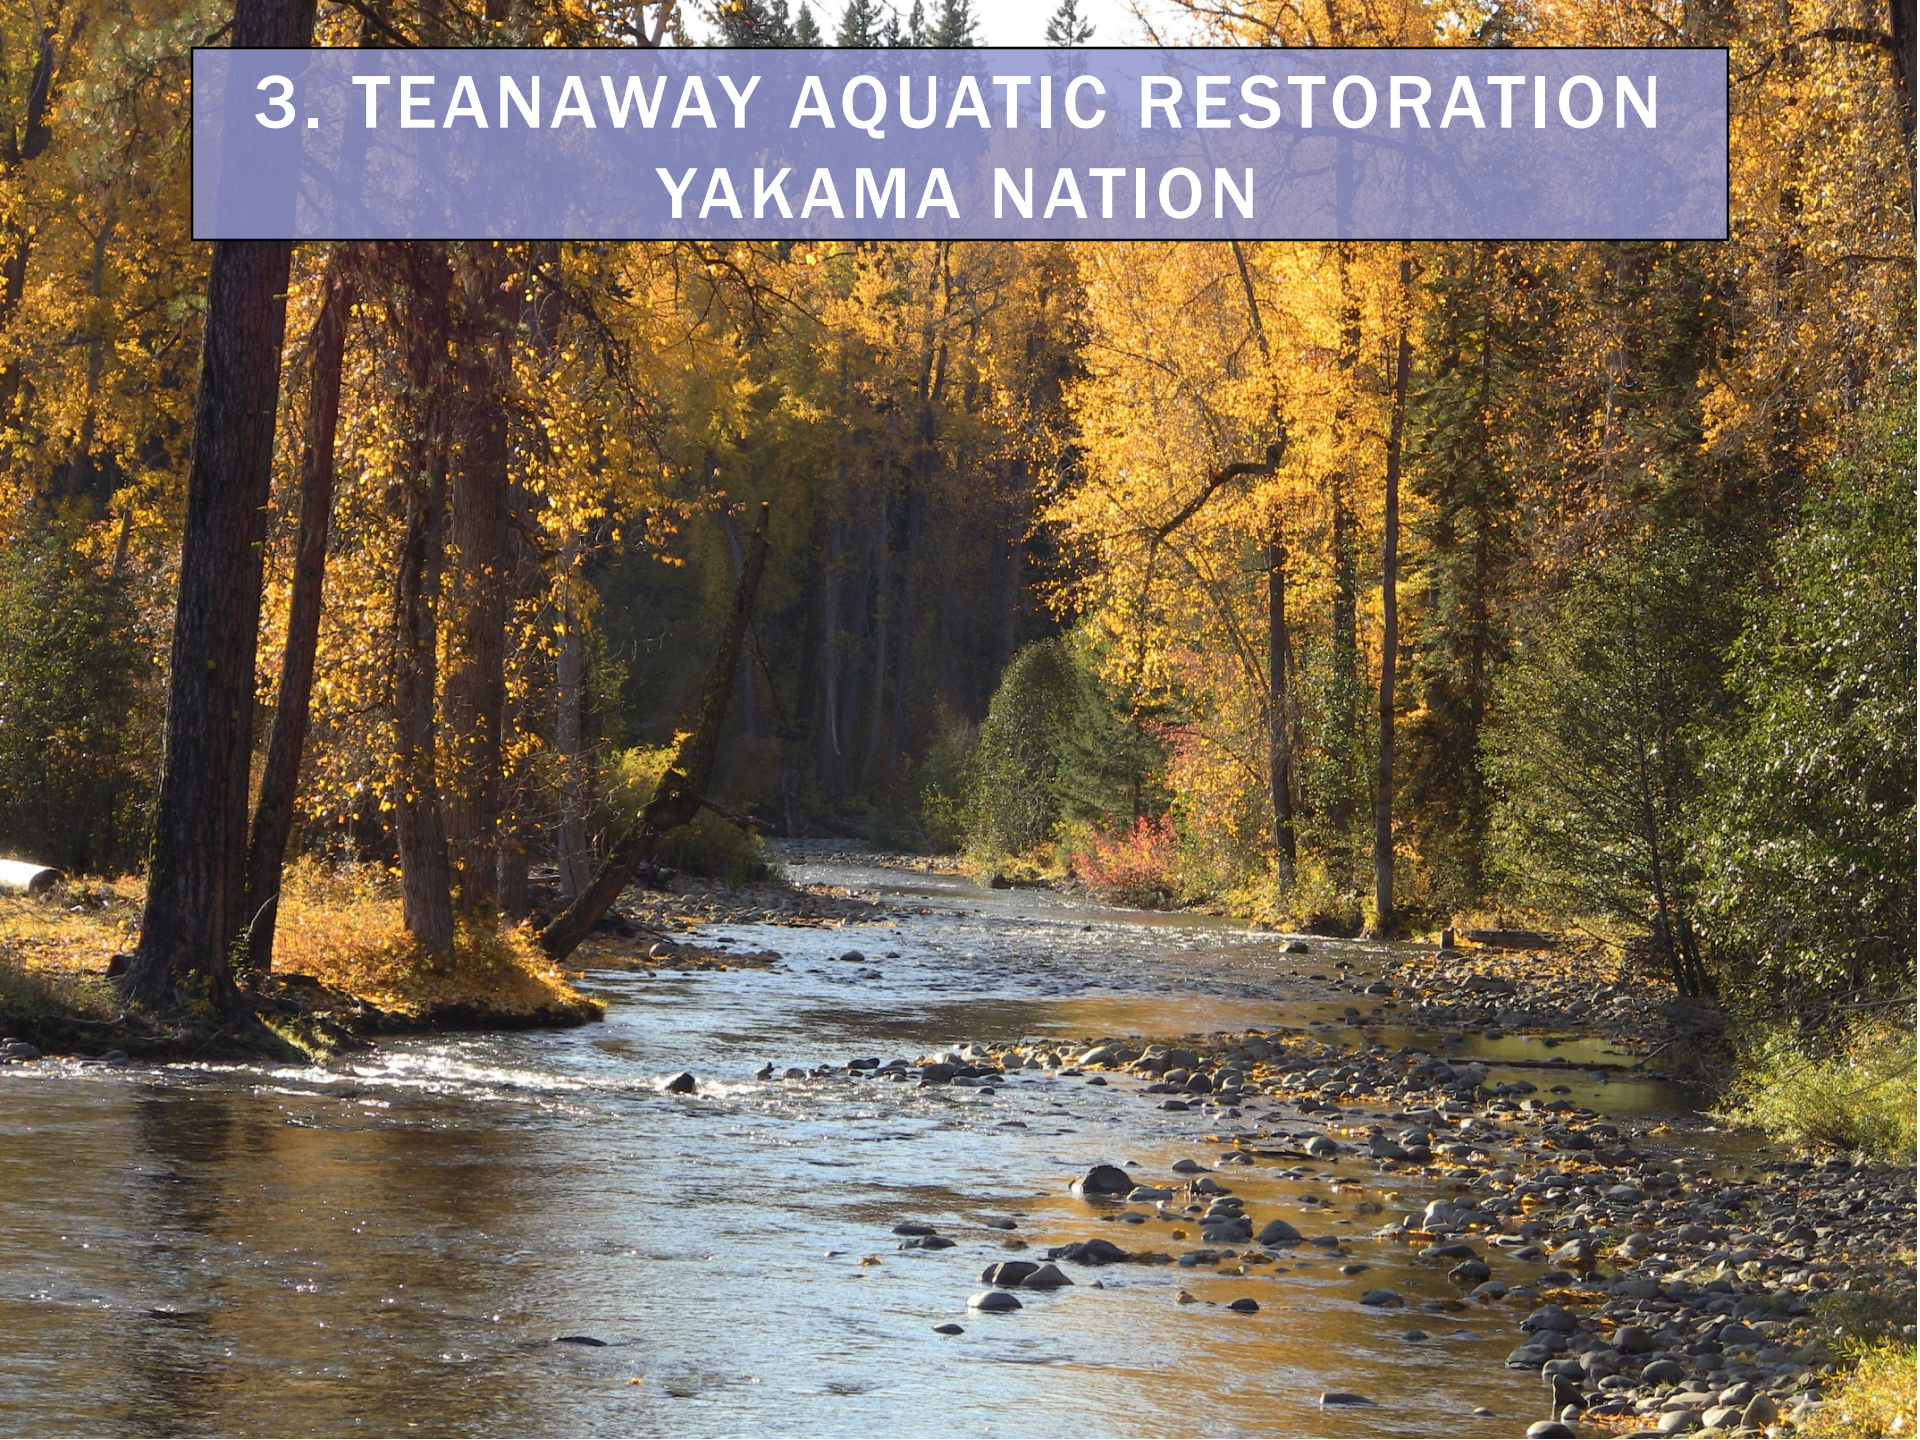
Indian Creek LWH Project: Pre-Project 2015

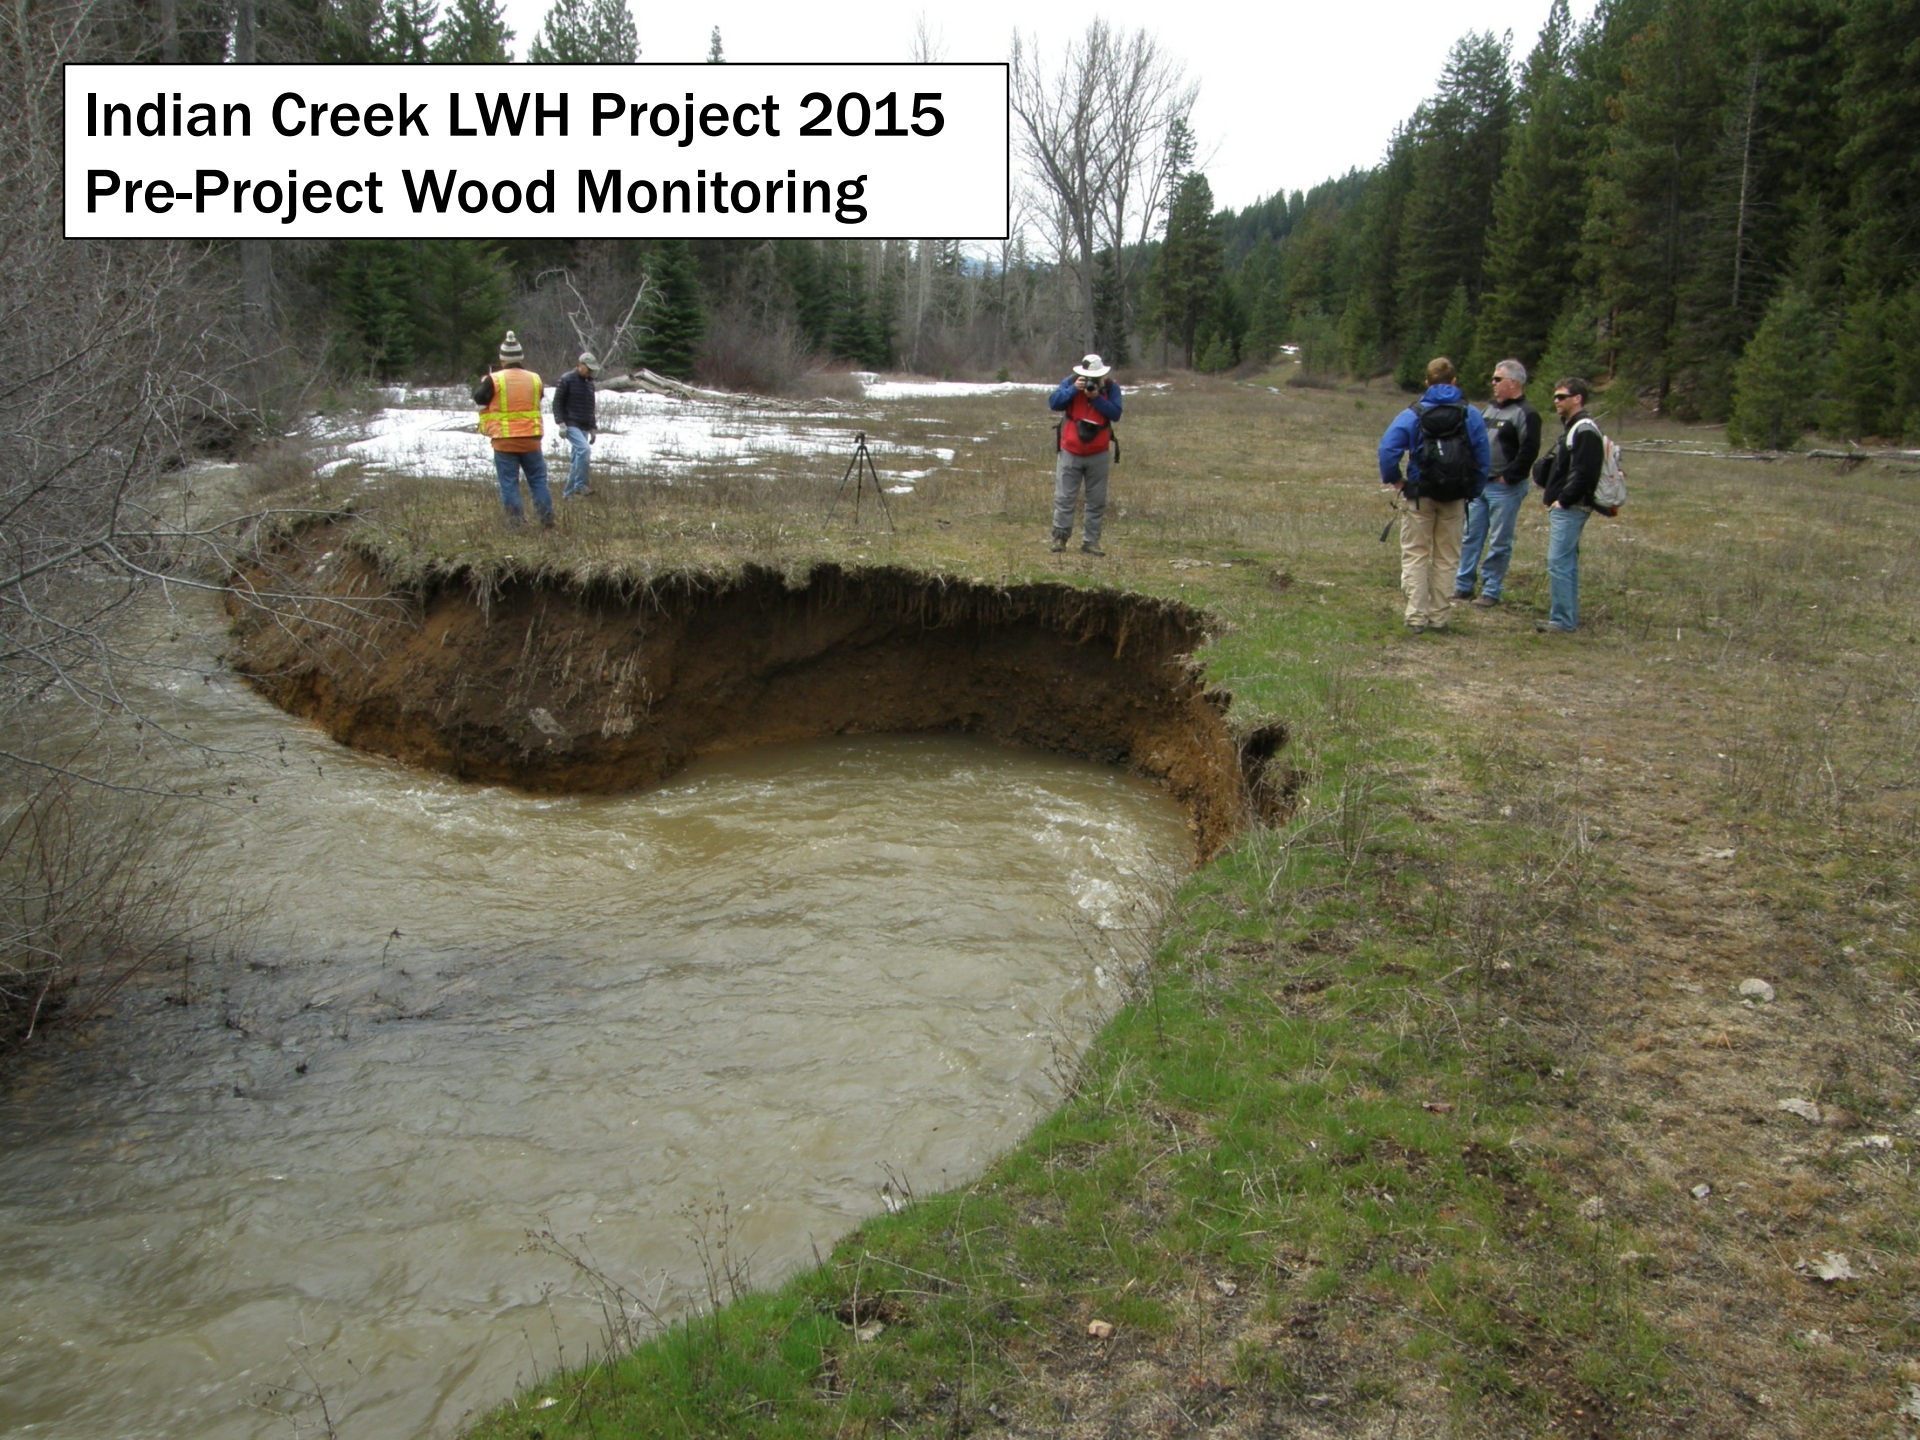
Indian Creek LWH Project 2016 Post-Project Wood Monitoring

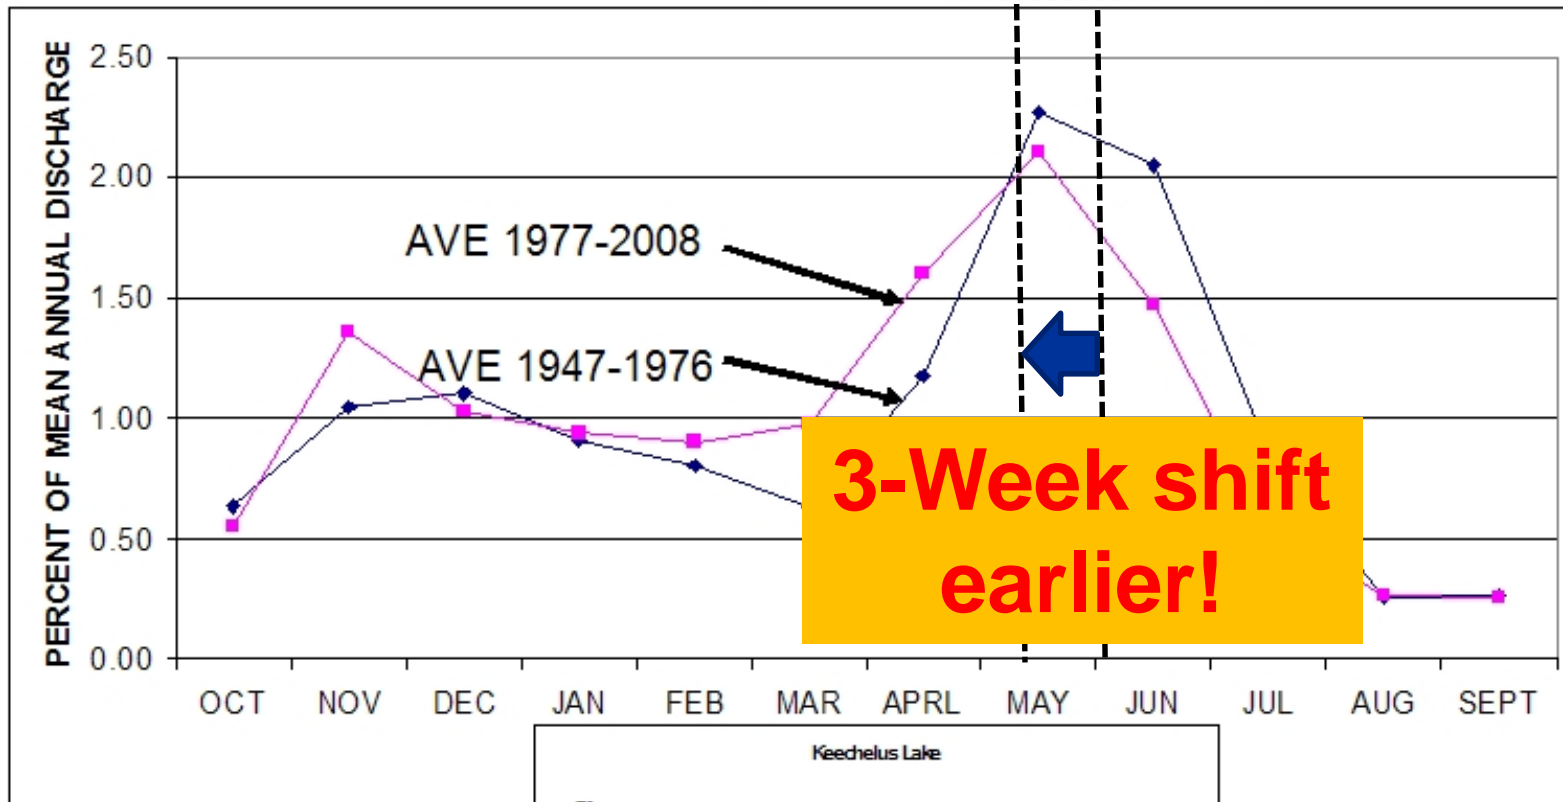
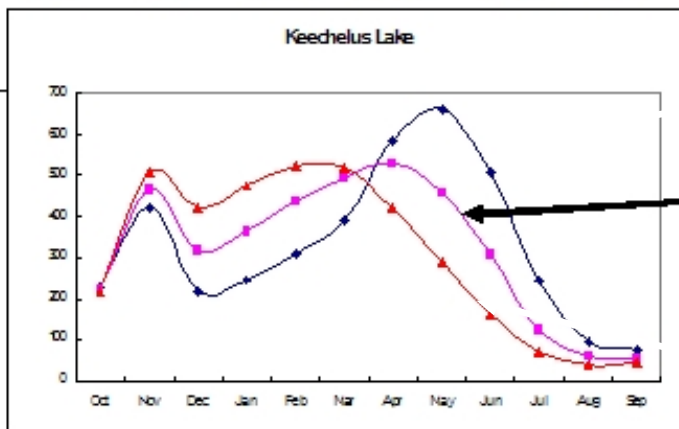
Yakima Hydrograph & Climate Change

Yakima River at Martin (Inflow to Keechelus Lake)
